Learnings from Ensham Experience – Water Quality Perspective

Regional Manager, Water Services
Central West Region

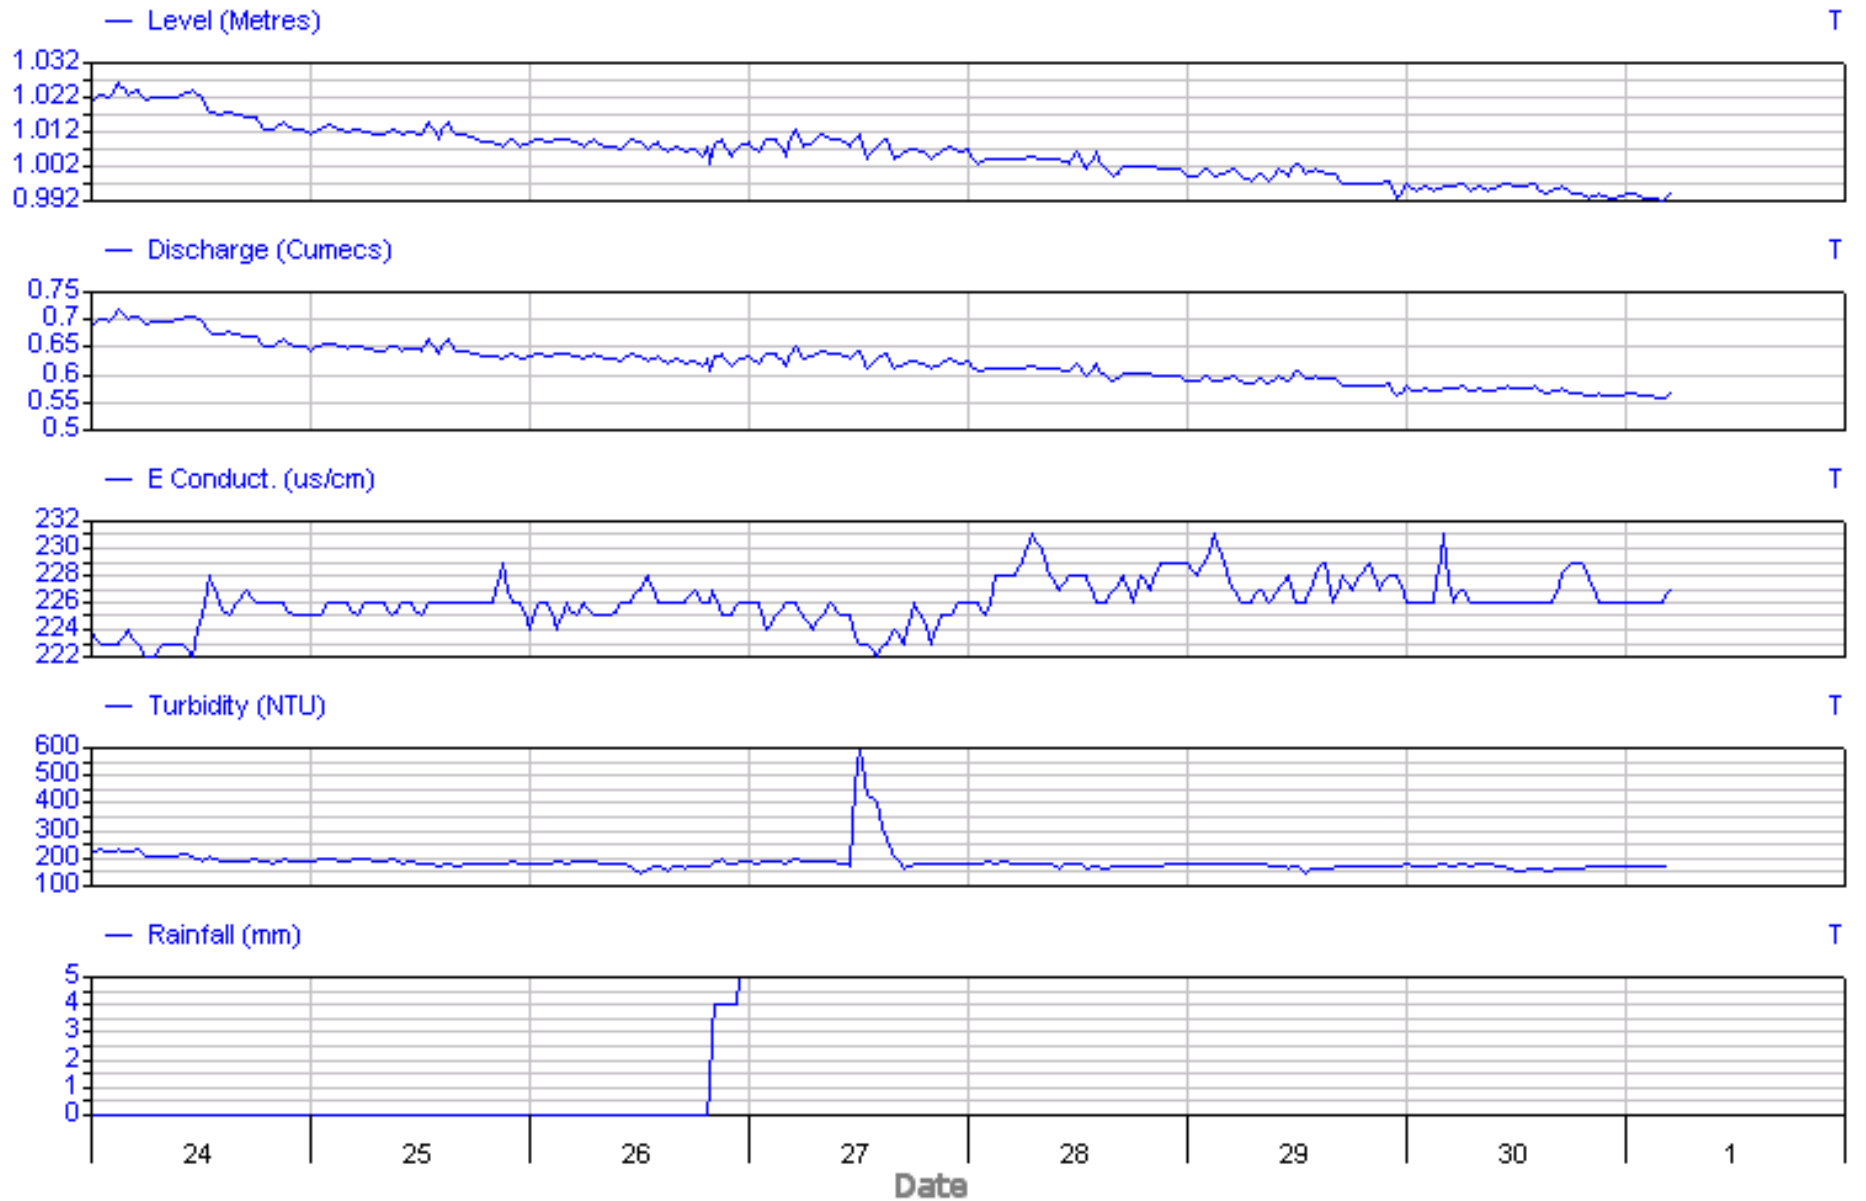
Site 130105A Mackenzie River at Coolmaringa

Period 8 Day Plot Start 00:00_24/06/2009

Plot End 00:00_02/07/2009

Unverified Telemetry Data

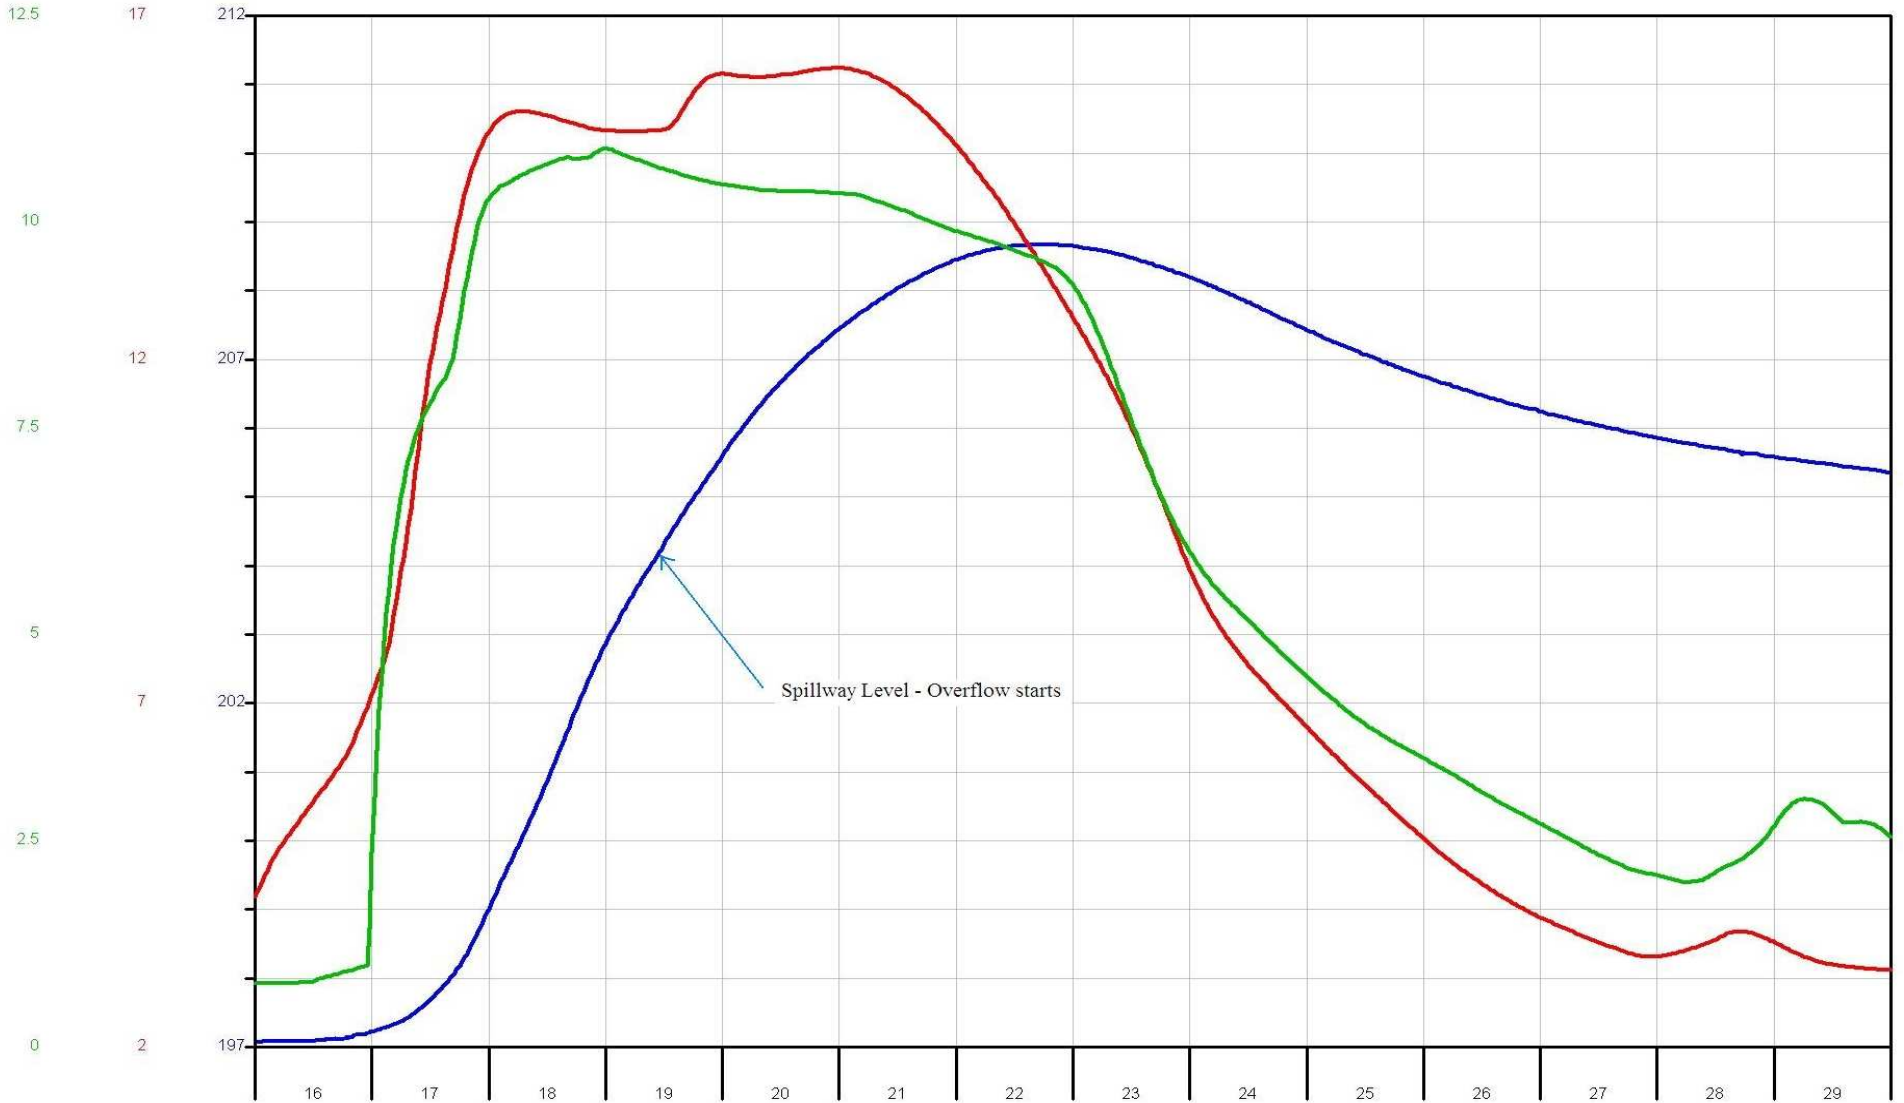
Period 14 Day Plot 16/01/2008 to 30/01/2008

130216A	Nogoa R_Fairbairn	Spillway	Level (Metres)
130209A	Nogoa R_Craigmore	Inflow	Level (Metres)
130206A	Theresa_Gregory Hwy	Highway	Level (Metres)

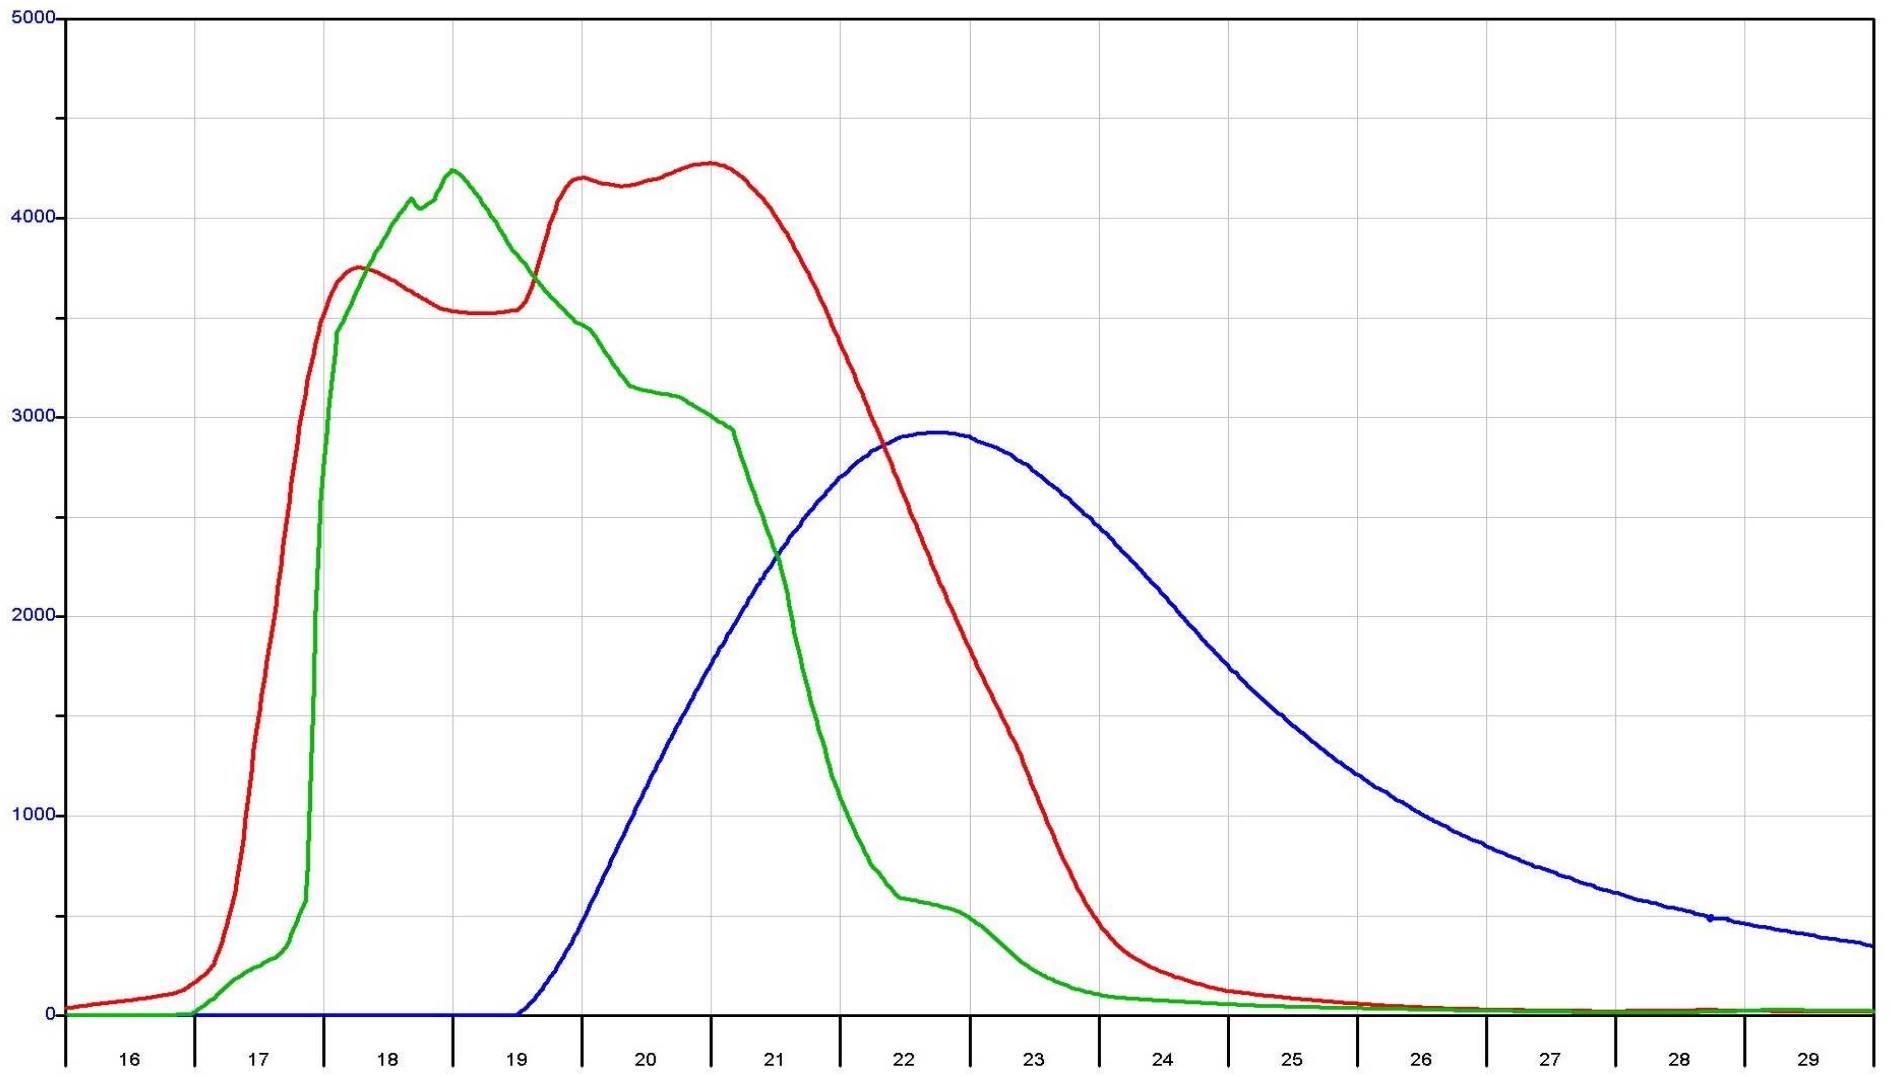
Period 14 Day Plot Start 00:00_16/01/2008 Plot End 00:00_30/01/2008

130216A	Nogoa R_Fairbairn	Spillway	Discharge (Cumeecs)	T
130209A	Nogoa R_Craigmore	Inflow	Discharge (Cumeecs)	
130206A	Theresa_Gregory Hwy	Highway	Discharge (Cumeecs)

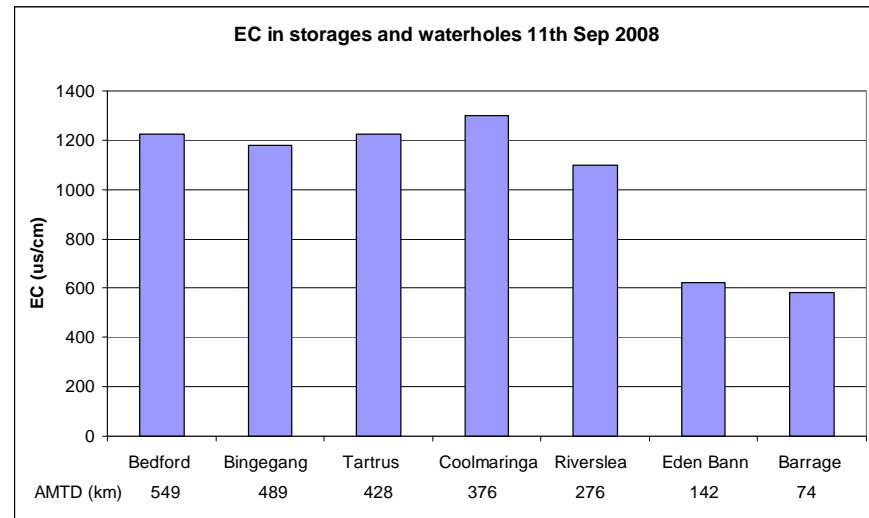
11th Sep 2008

EC in storages and waterholes

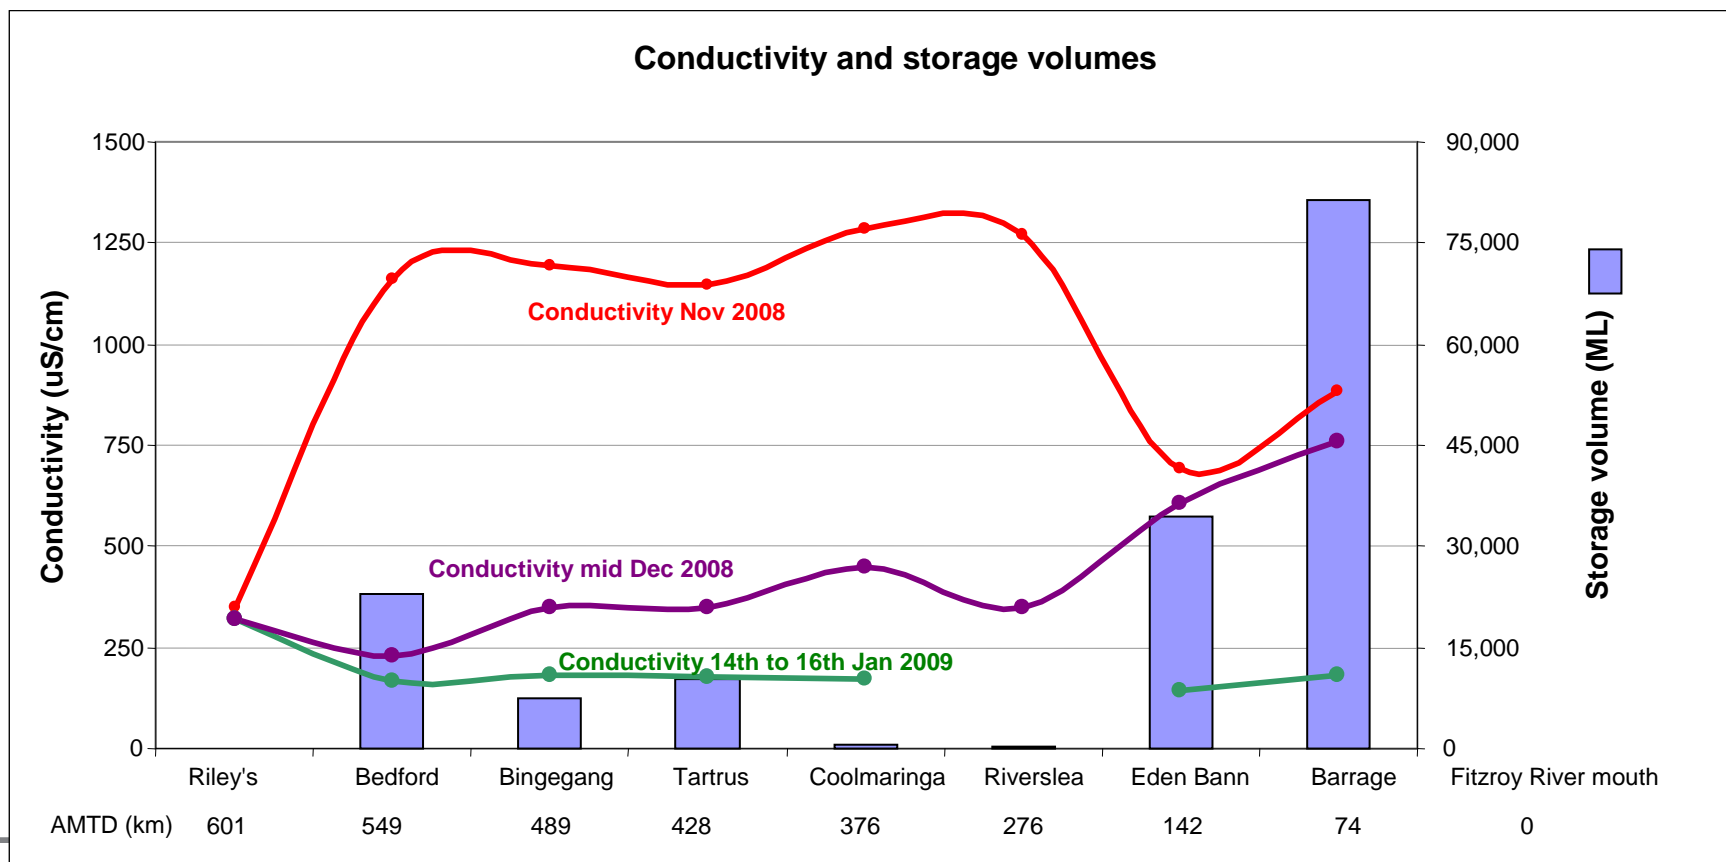
Mackenzie and Fitzroy Rivers - Conductivity

Nov 2008 to Jan 2009

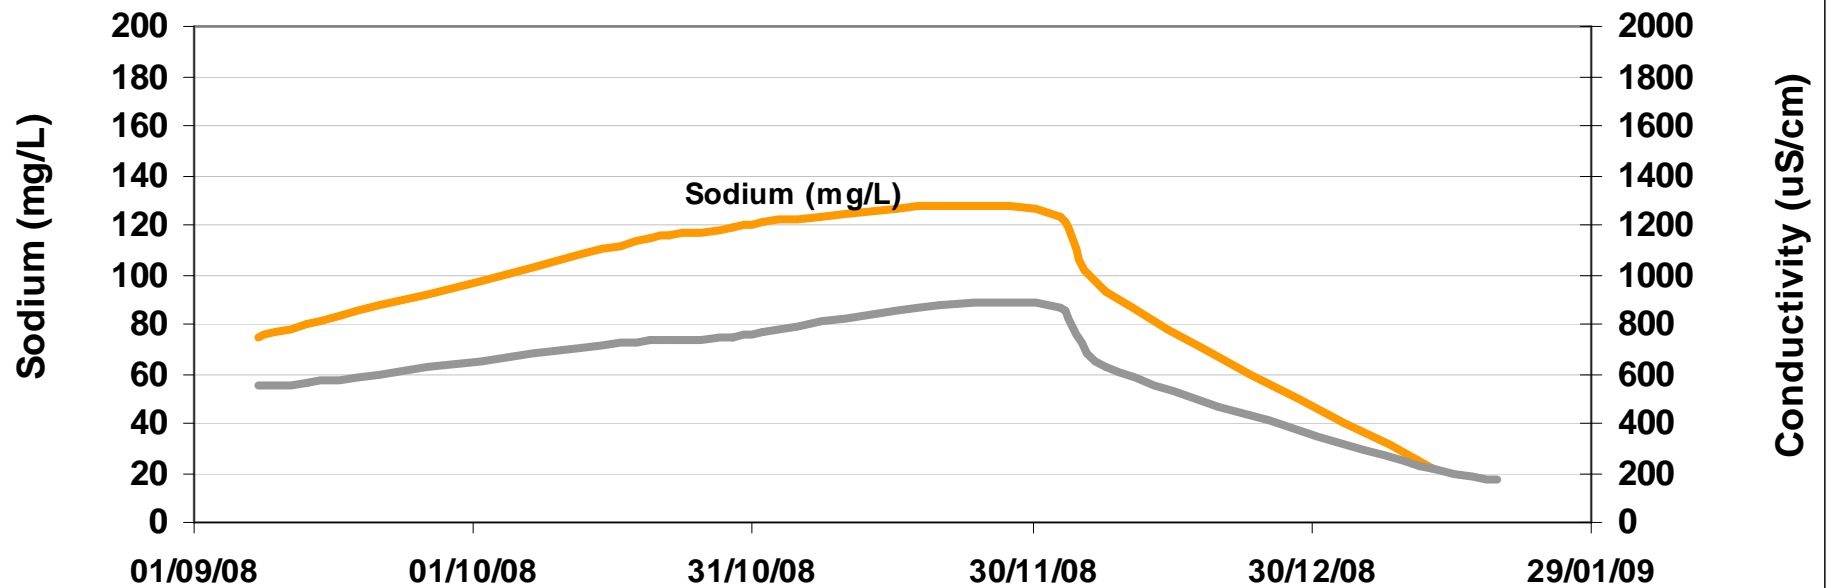
Fitzroy River Barrage - Rockhampton - town water intake Sodium and Conductivity levels

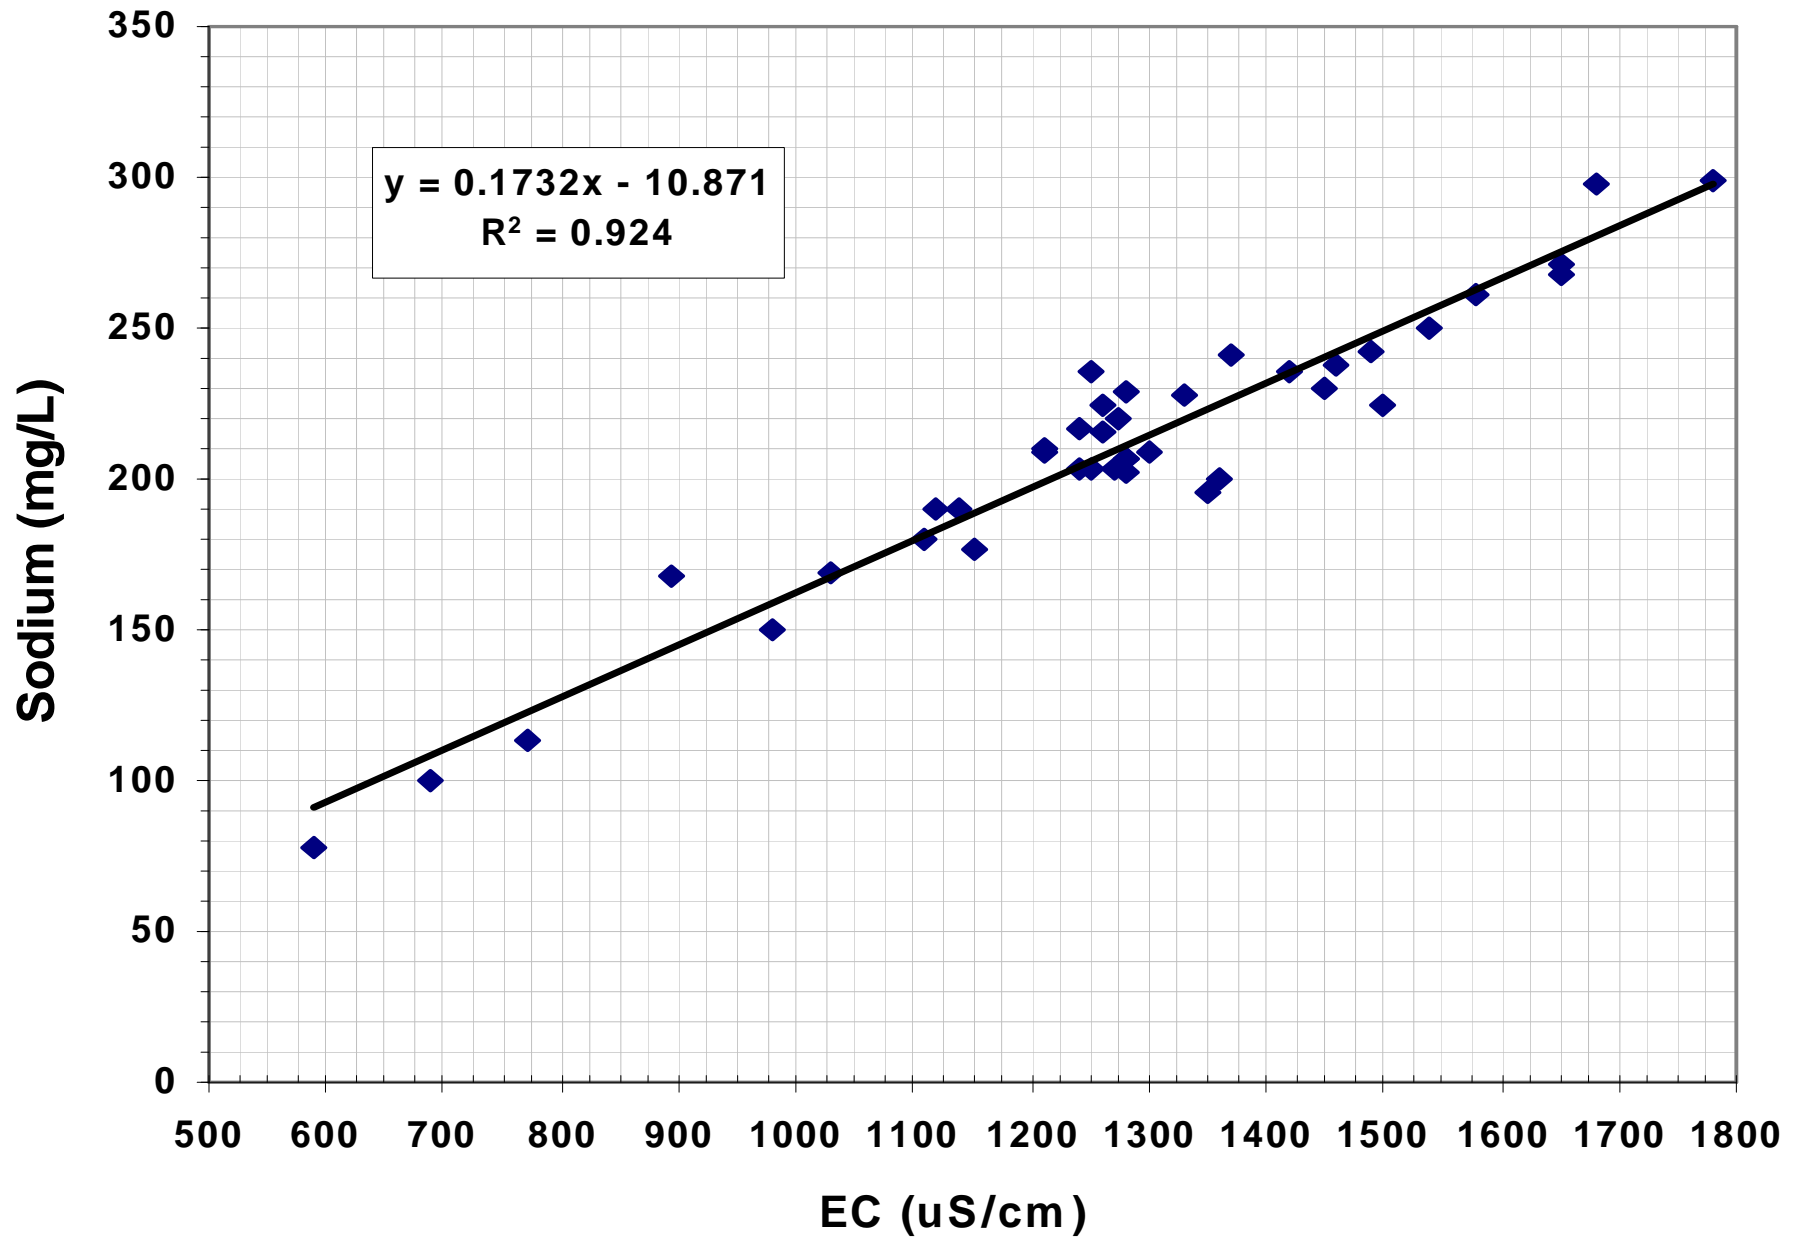
**Mackenzie River Sodium (mg/L) and EC
42 paired samples (Ensham release water)**

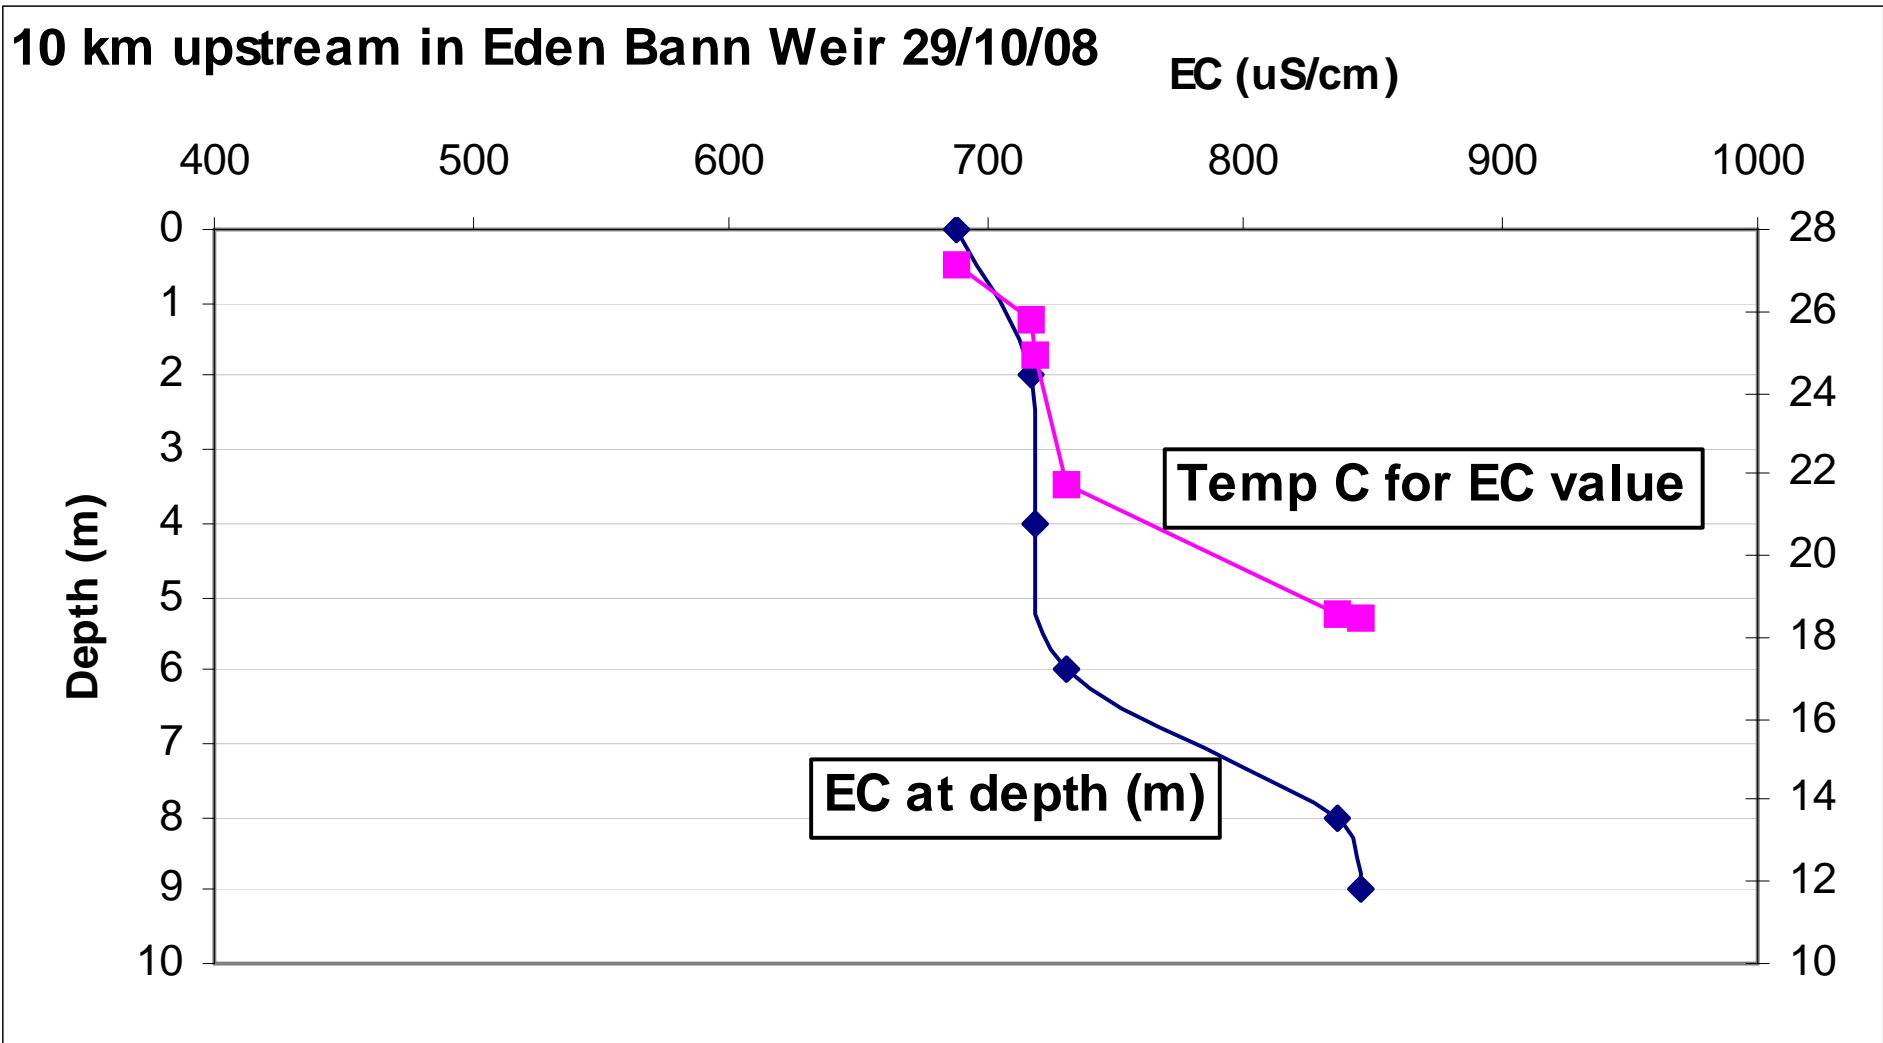
10 km upstream in Eden Bann Weir 29/10/08

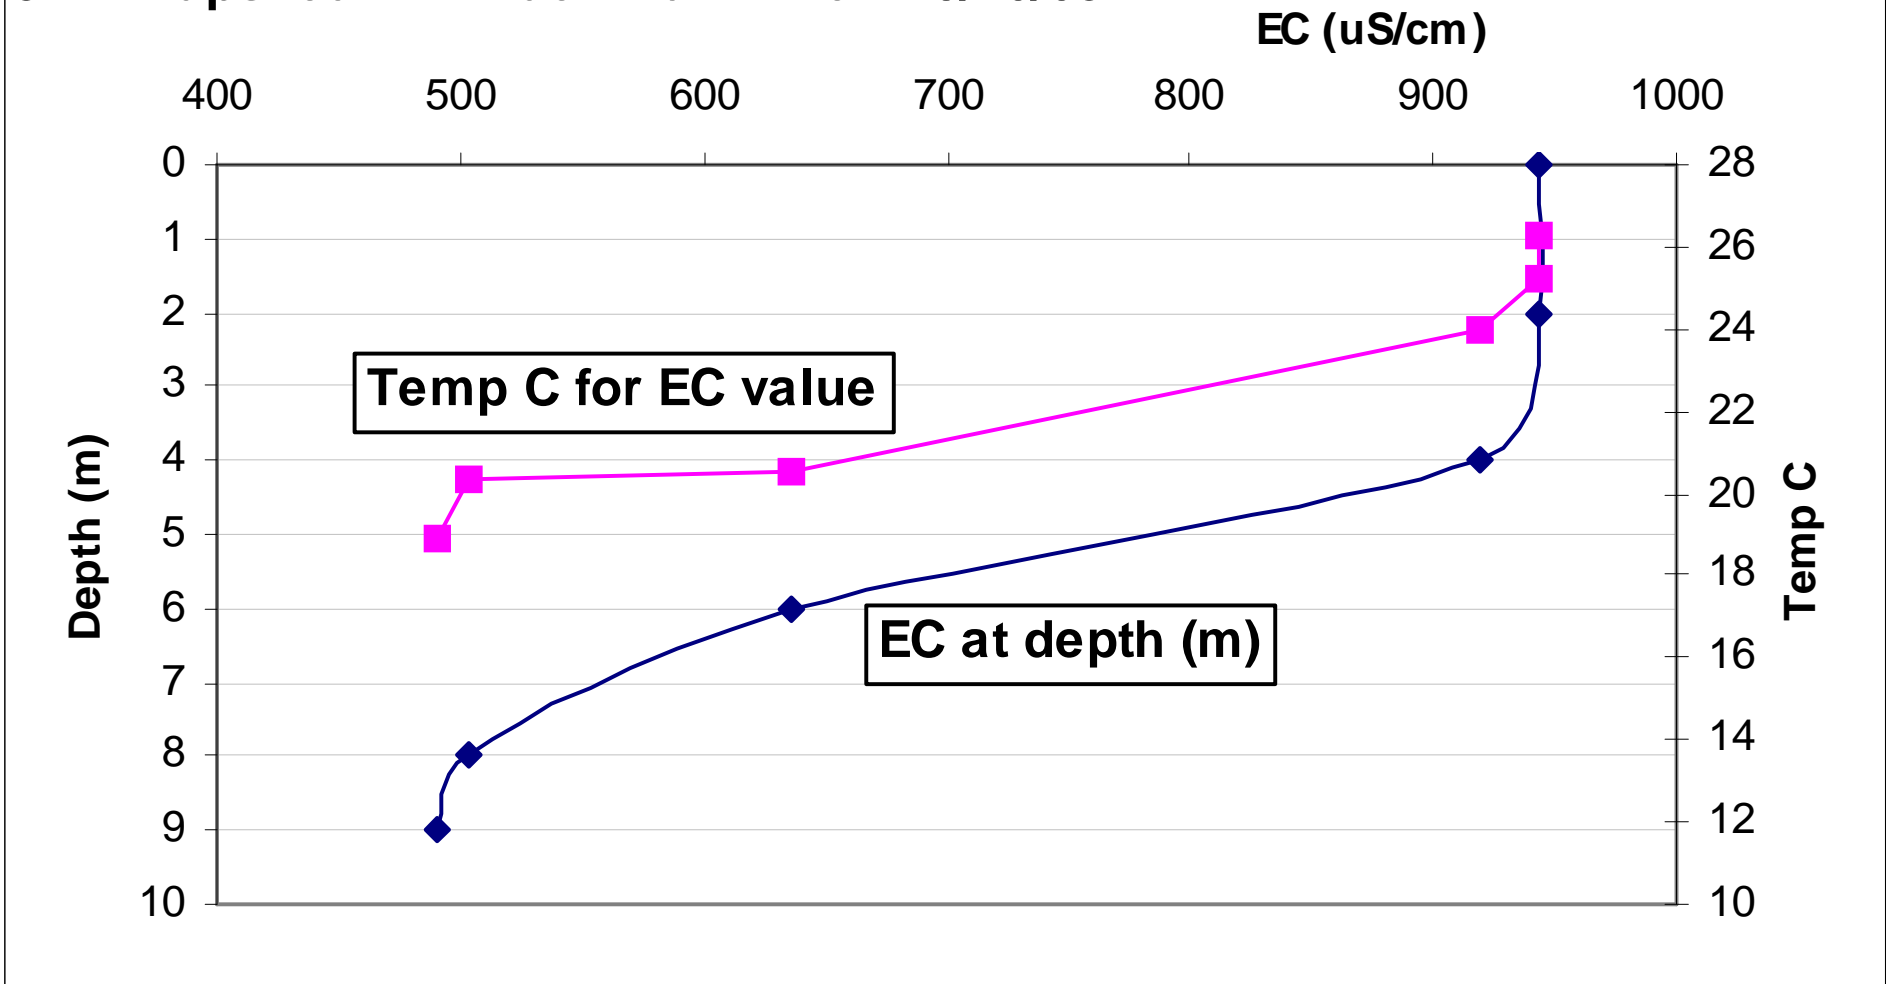
32 km upstream in Eden Bann Weir 29/10/08

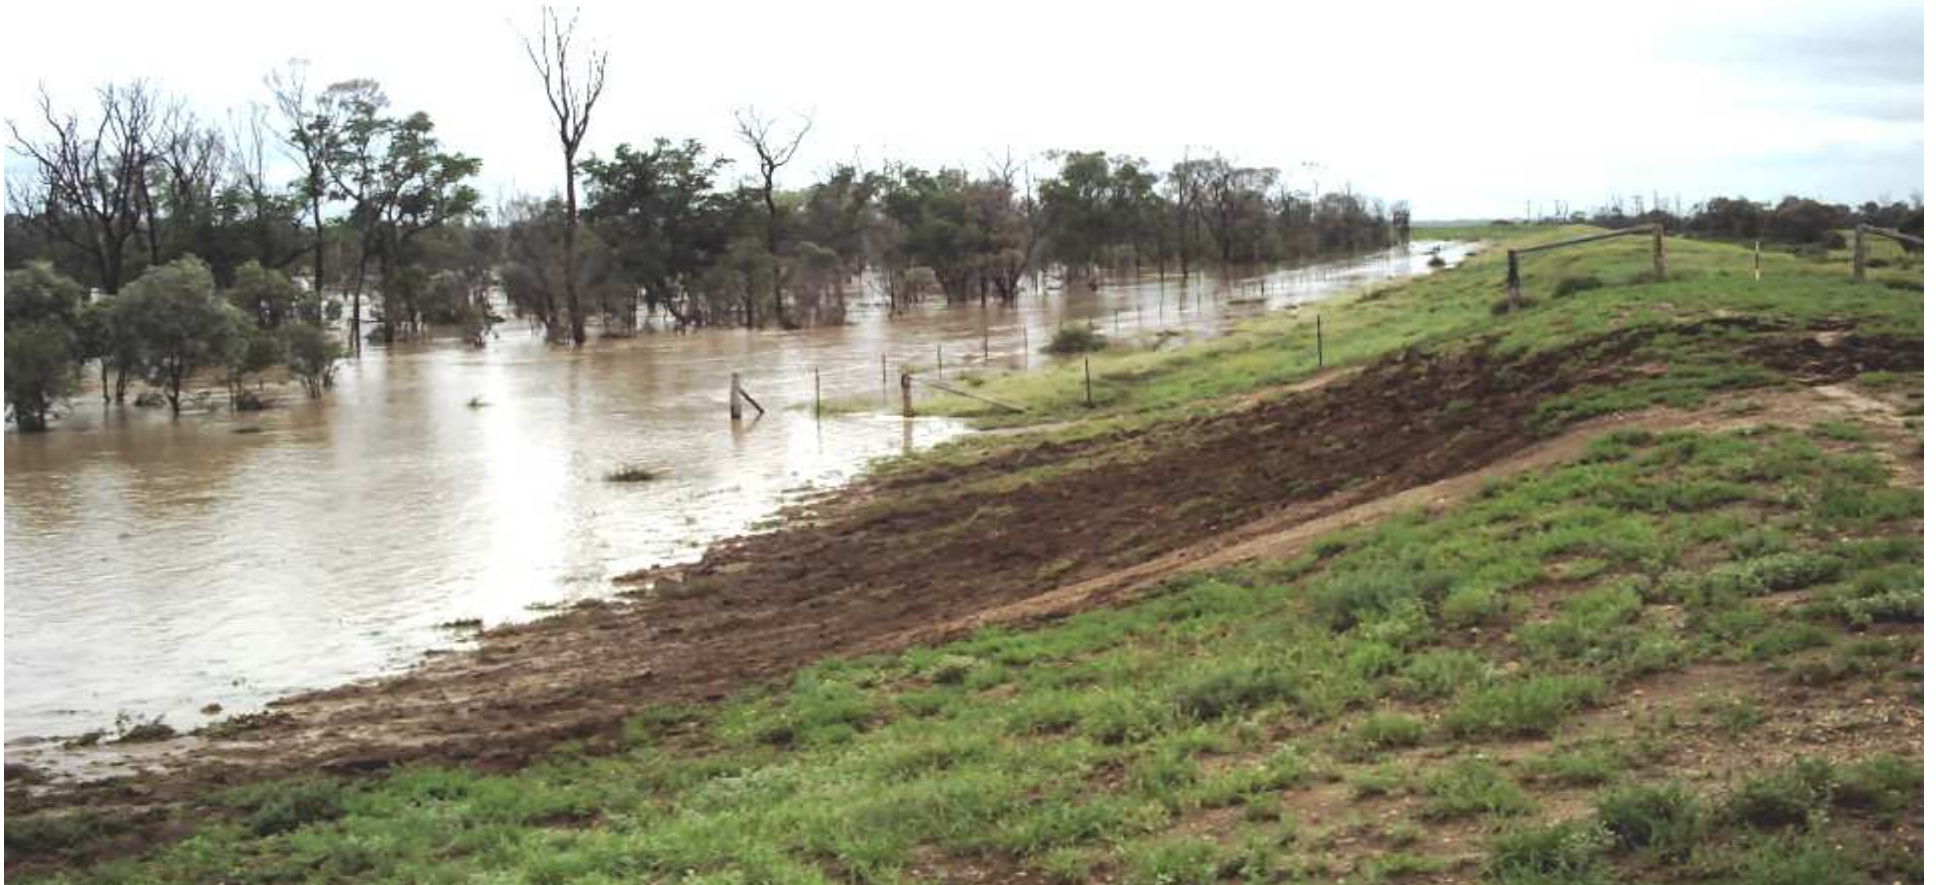
20th Jan 2008.

Nogoa River levee banks at Bridge Flats.

Approximately 18km upstream Duckponds via the Nogoa Rivers main channel.

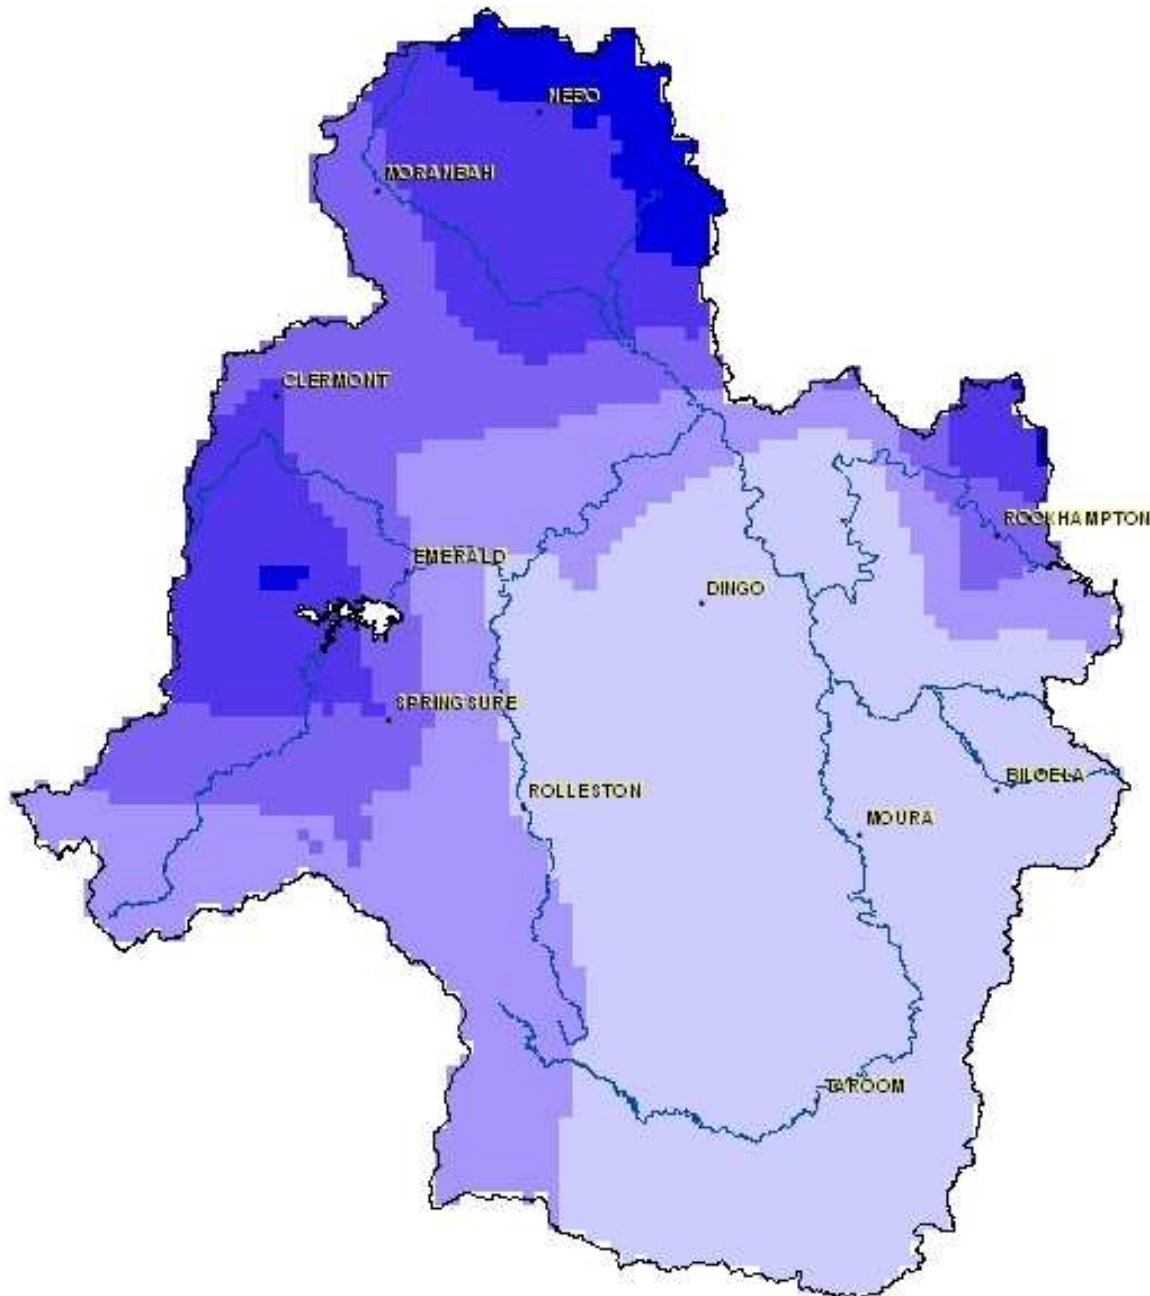
2008 total rain map

Rainfall (mm)

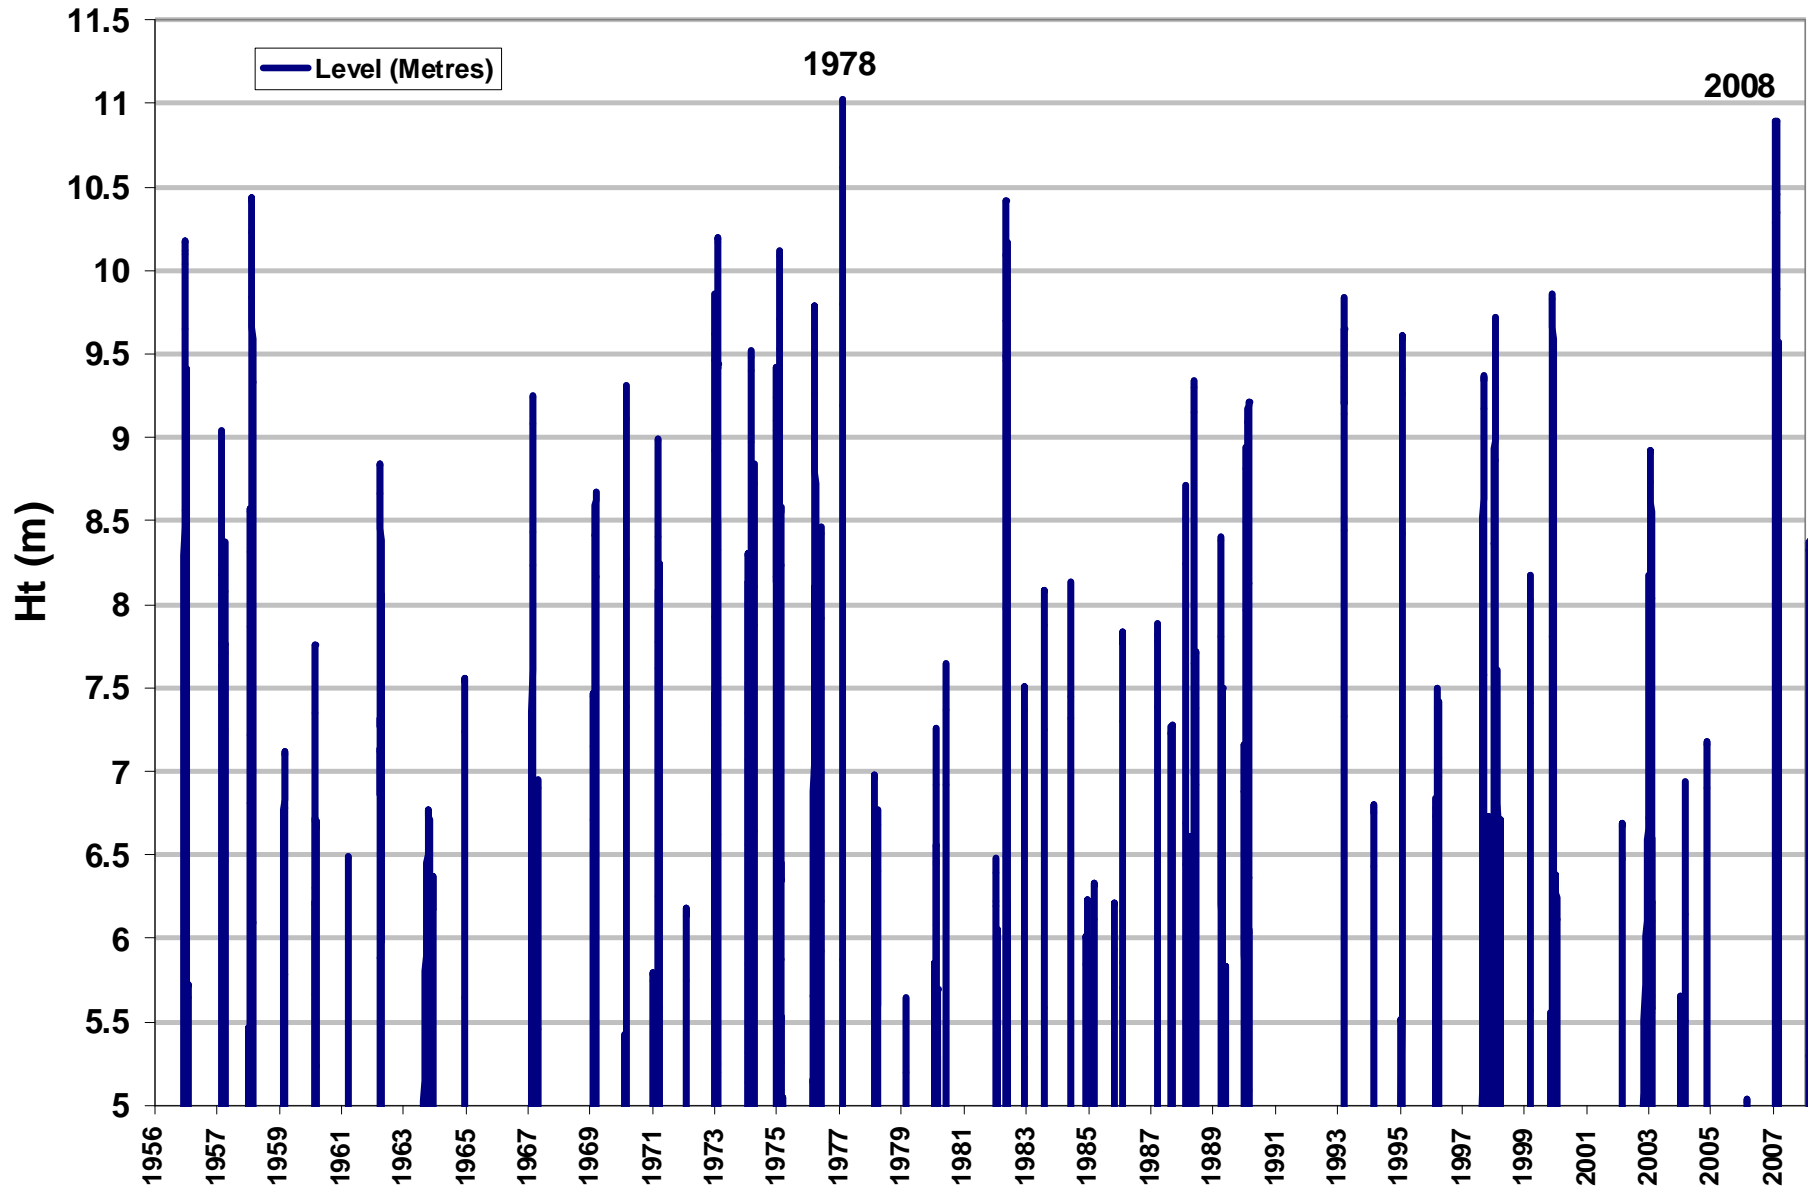
Theresa Ck at Main Road 52 year record
